TECHNICAL ASSISTANCE TEAM FOR EMERGENCY RESPONSE REMOVAL AND PREVENTION
EPA CONTRACT 68-01-7367

Re: Denune/Westfall Site, Columbus, Ohio
TDD# 5-8905-22

Site Investigation

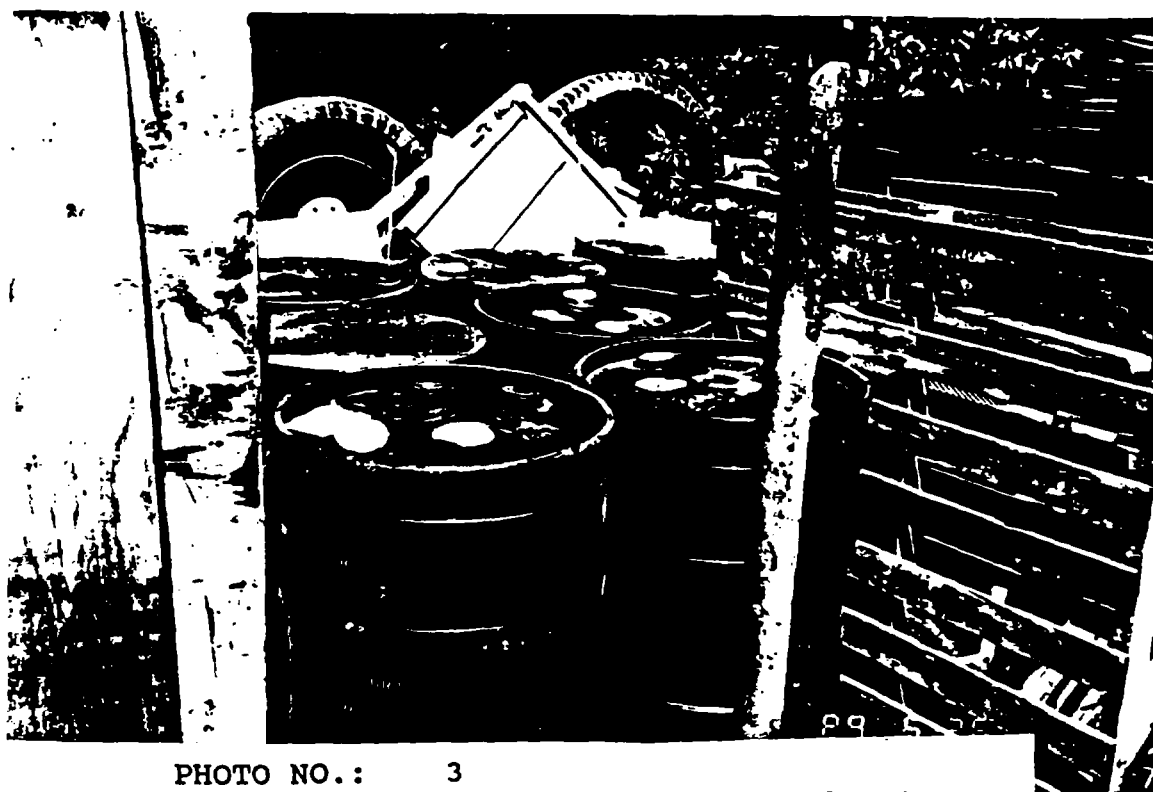
PHOTO NO.: 3
SITE: DENUNE SITE, COLUMBUS, OHIO
TIME: 1000 - 1500 hours
DATE: 5-26-89
DESCRIPTION: Seven of the eight drums on
site staged in loading dock
area. OEPA sampled three of
these drums for PCB analysis.
PHOTOGRAPHER: J. Binkley

The estimated nine drums of Askarel on site will be placed in 85-gal overpacks and staged for disposal. Likewise, the estimated three 5-gal pails of Askarel will be placed in a single drum and also staged for disposal. An estimated 650 gallons of Askarel in the bottom of the 40 yd³ roll-off box will be pumped into 55-gal drums and also staged for disposal.

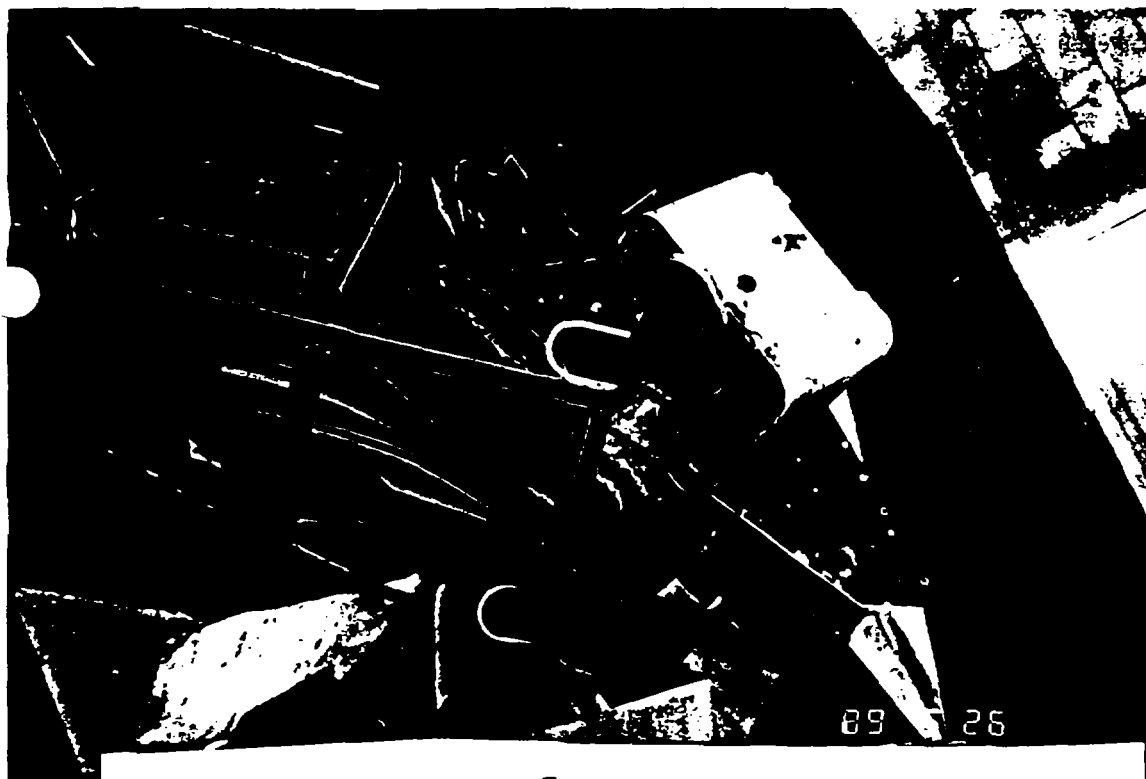
PHOTO NO.: 7
SITE: DENUNE SITE, COLUMBUS, OHIO
TIME: 1000 - 1500 hours
DATE: 5-26-89
DESCRIPTION: Debris staged in roll-off box.
Note transformer plates.
PHOTOGRAPHER: J. Binkley *JB*

Two 20-yd³ lined, hazardous material roll-off boxes will be mobilized to the site and placed adjacent to the 40-yd³ roll-off box. All debris will be transferred using a backhoe or manually from the 40-yd³ roll-off box and the dumpster into the two 20-yd³ roll-off boxes.

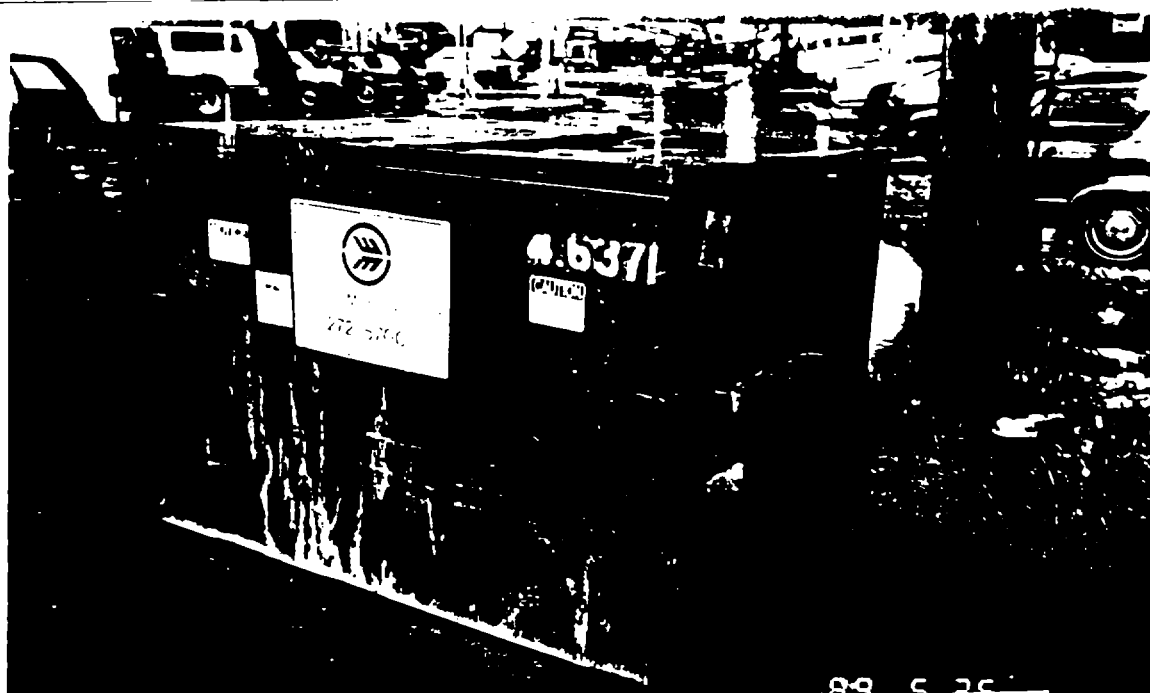
PHOTO NO.: 8
 SITE: DENUNE SITE, COLUMBUS, OHIO
 TIME: 1000 - 1500 hours
 DATE: 5-26-89
 DESCRIPTION: Dumpster containing PCB
 transformer debris. Note PCB
 warning stickers placed on
 dumpster by OEPA.

The roll-off box and dumpster will be decontaminated using a steam jenny to apply a mixture of pentanone and water. Decontamination liquid will be collected and placed in an estimated five 55-gal drums. Following decontamination, post-cleanup swipe sampling will be conducted to confirm that cleanup standards were achieved.

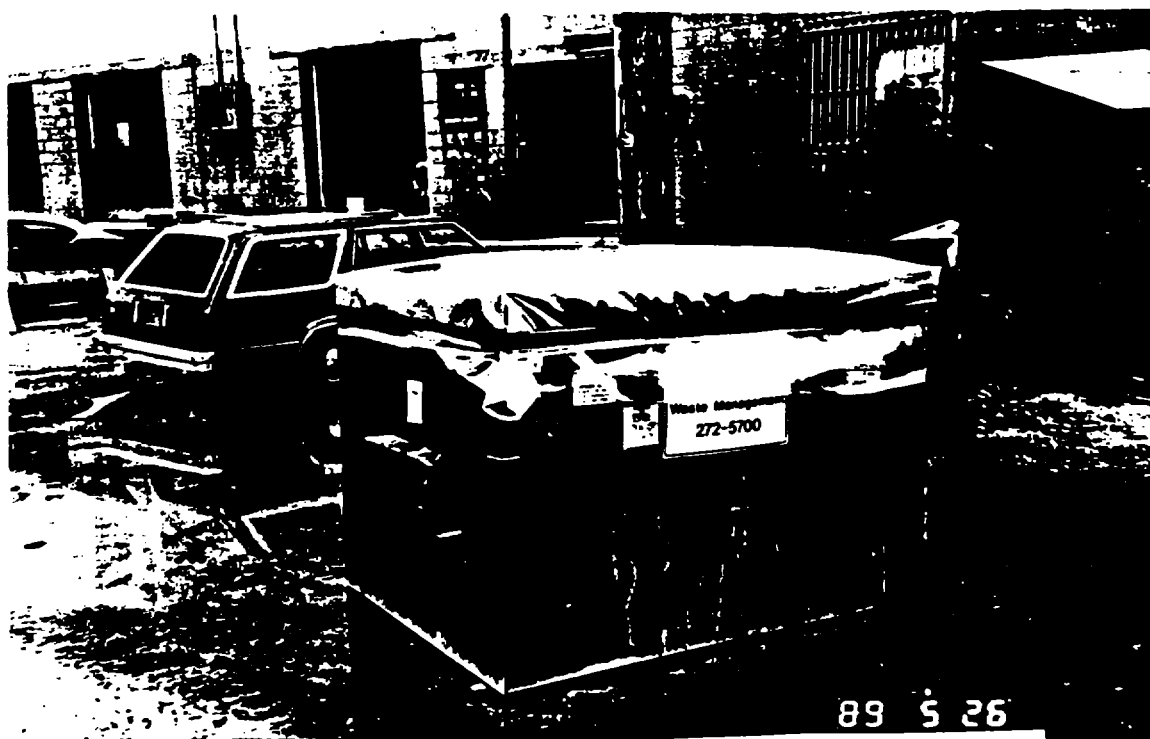
PHOTO NO.: 9
 SITE: DENUNE SITE, COLUMBUS, OHIO
 TIME: 1000 - 1500 hours
 DATE: 5-26-89
 DESCRIPTION: Dumpster containing PCB
 transformer debris after being
 covered by OEPA officials.

As a temporary measure, the OEPA covered the trash dumpster and roll-off box with Visqueen to prevent further contamination.

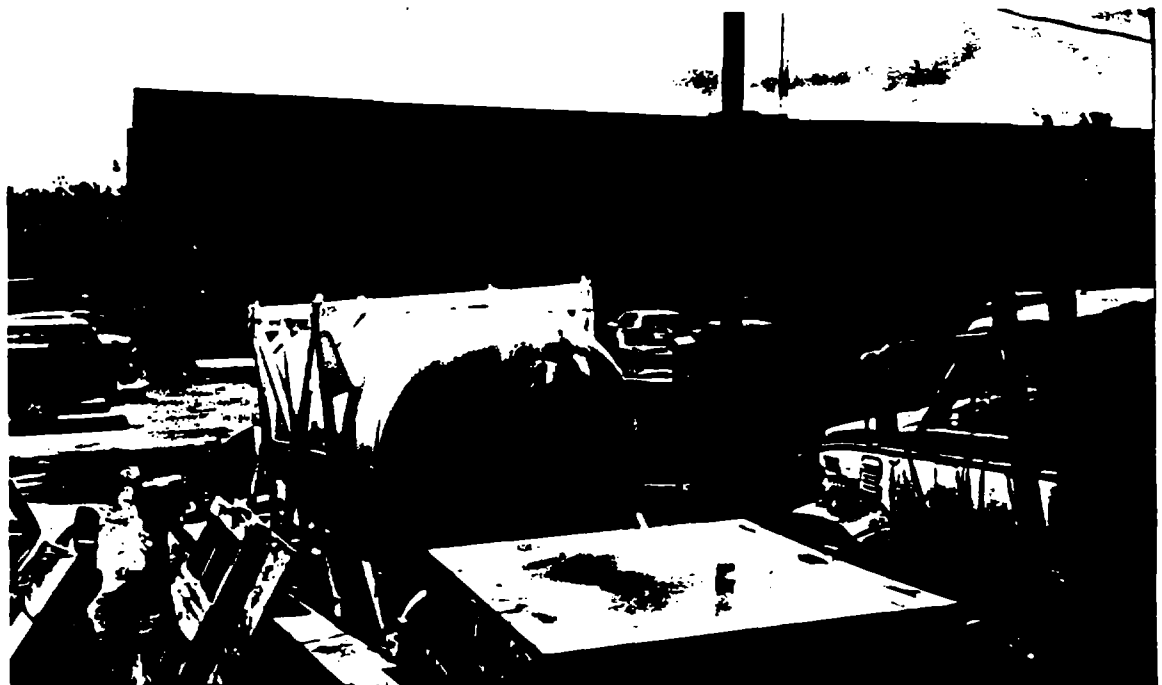
PHOTO NO.: 13
 SITE: DENUNE SITE, COLUMBUS, OHIO
 TIME: 1000 - 1500 hours
 DATE: 5-26-89
 DESCRIPTION: Liquid oxygen tank situated on
 trailer parked in loading dock.
 According to OEPA, the tank
 contained a white powder
 material.
 PHOTOGRAPHER: J. Binkley
